Crime & Safety Technical Memorandum

Third Avenue Transit Corridor Improvement Project

Prepared for:
Seattle Department of Transportation
King County Metro Transit
September 2014

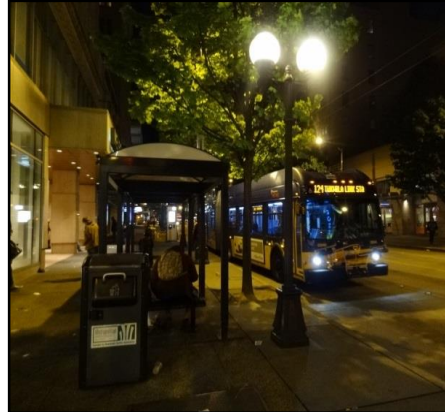
Lighting in the corridor is accomplished using high-pressure sodium (HPS) vapor lamps with globe fixtures that are energy inefficient, and create light trespass and light pollution.

The quality of the yellow light does not create a positive experience. Additionally, the glare and shadow qualities of the lighting source and luminaires do not promote facial recognition of strangers.

Develop a new lighting template that replaces HPS vapor lamps with LED lighting and includes fixtures that reduce light trespass and pollution.

Ensure that all areas intended for legitimate use, including pathways, are well lit.

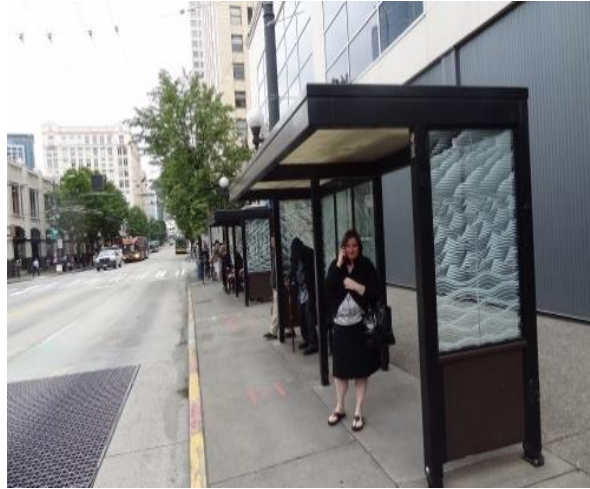
The standard METRO bus shelters (seen at the Pike Street, Union Street, and Marion Street intersections) are not transparent, provide hiding spaces, and make patrol by police and security more difficult.

In addition, benches within some shelters enable loitering. The police officers interviewed by the project team confirmed these observations. New bus shelters that exist in other places throughout the city better promote visibility and natural surveillance.

Develop a transit shelter that avoids any obstructions to visual sight lines or pedestrian circulation patterns, similar to the new First Hill Streetcar shelters.

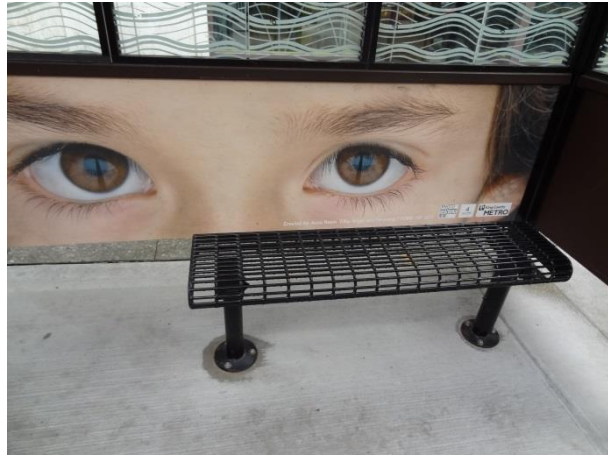
Presently many different types of benches are used along Third Avenue. Un-segmented benches promote loitering because they allow for lying or sleeping behavior and lack the boundary definition that would encourage use by multiple people.

Replace existing benches with segmented benches or benches with intermittent rails.

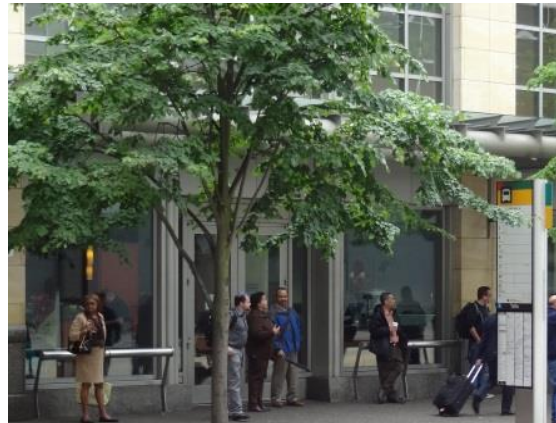
Leaning rails provide the ability to lean and rest, while protecting building facades. However, they also encourage waiting transit passengers to linger and effectively narrow the available walking corridor.

At high-traffic locations, remove benches completely and implement leaning rails. These are already successfully used at several bus zones on the corridor, including Union Street.

Develop a specific leaning rail standard and guideline that is adaptable for installation on the sidewalk or other parts of the public right-of-way that does not touch or interfere with the private sector architecture or other urban amenities.

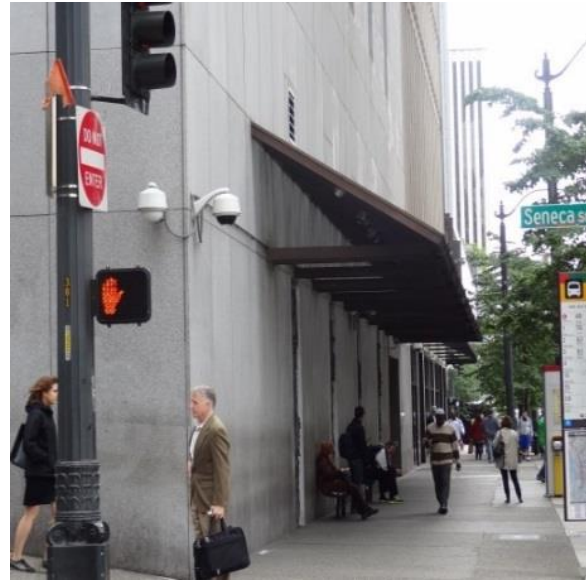
Building awnings serve different purposes throughout the corridor. In some areas with significant “merchant zone” activity, awnings provide shelter for patrons conducting business (i.e. sidewalk cafes, storefront promotional areas, etc.). Because they have a legitimate purpose for lingering under the awnings, these patrons serve as responsible guardians for the public realm.

Most of the awnings in the Business District connect to large office complexes with no retail frontage. These awnings serve primarily to shelter pedestrians from the elements as they walk along the street or wait for transit. This is a much more transient type of activity that does not encourage responsible guardianship the same way retail business does.

Develop a new set of guidelines for building awnings which differentiates awnings meant to shelter retail business patrons from those meant to shelter pedestrians and waiting transit passengers. Awnings specific to the latter group should follow a different set of design guidelines to enhance the natural surveillance abilities of people in motion. Ideally, they should be translucent to let in as much daylight as possible, and have underlighting fixtures to illuminate the area underneath the awning at night.

Building awnings should be designed with some thought to both the available sidewalk width and proposed sidewalk use. If a sidewalk is too narrow to facilitate a waiting area in addition to a walking corridor, the awning should be disconnected from the building in a way that allows stormwater to stream down the building façade to discourage people from leaning against the building.

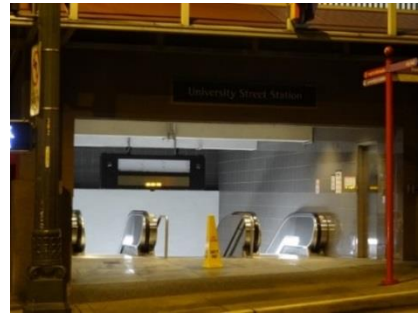
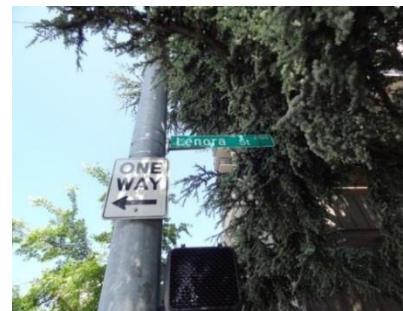
A variety of different signage for traffic and transit is found throughout the corridor. The inconsistency creates confusion regarding the space's intended and legitimate usages, and does not aid in wayfinding.

Additionally, some signage is difficult to see or is obscured.

Develop a street template for uniform signage throughout the corridor for all transportation-critical infrastructure such as street signs, bus stops, rules of conduct, and tunnel entrances. This could be as simple as updating corridor signage to meet MUTCD standards.

The template should include providing uniform street sign placements visible to all users of the corridor. For example, motorists cannot see street names embedded in the concrete sidewalk; they need signs on signposts as well.

Conduct a visibility review with SDOT Urban Forestry to identify locations throughout the corridor where tree overgrowth has reduced visibility of traffic and transit signage. Schedule regular maintenance to coincide with the growing season.

Ensure that all traffic and transit signs are well-lit at night and visible from a distance. Tunnel station entrances should have 270-degree visibility from the street.

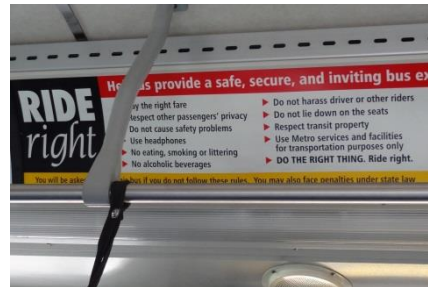
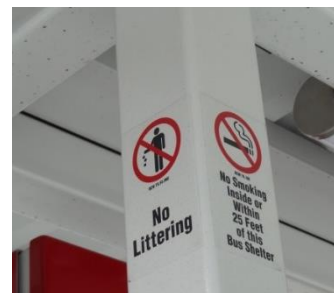
Many rules for appropriate conduct are posted throughout the corridor. However, they suffer from several problems.

While a complete list of transit rules are clearly posted in buses, they are seldom seen in bus shelters. When they do appear in shelters, they are most often found in an abbreviated form and inconspicuous location that doesn't fully convey their importance.

Perhaps more importantly, many posted rules are simply not enforced and thus ignored by transit passengers. This has the effect of delegitimizing the rules. Users become disengaged with the idea of responsible guardianship as they see others disregard the rules with no consequence.

Establish and post rules of conduct consistently throughout the corridor.

Post rules on transit shelters or at bus zones to alert riders prior to boarding the bus.

Post rules for public areas at eye level and with maximum visibility. Clearly identify who the owner of the space is (for example, SDOT or METRO) and provide contact information for reporting rule violation.

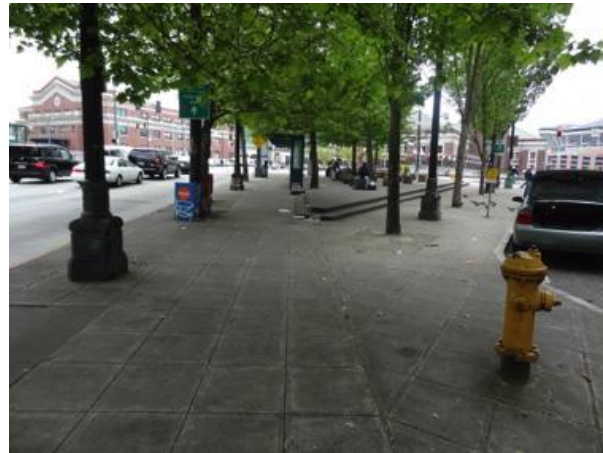
Along the corridor landscaping was observed to obstruct visibility, impeding natural surveillance and creating confusion regarding the correct pathway.

Develop a landscape template for pruning trees, ground cover, plants, screening, dog rocks, and watering and care of plants. The template should also ensure that plants do not obstruct visibility and direct users on the correct pathway.

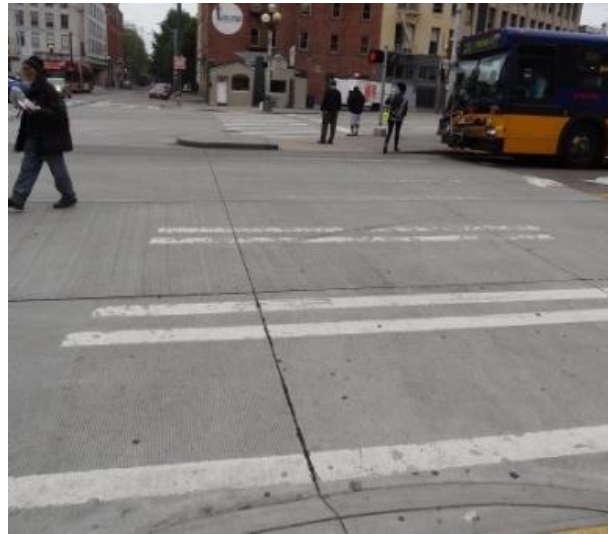
Many crosswalks along Third Avenue are deteriorating and unclear

Restripe and refresh all crosswalks throughout the corridor.

If possible, create a new crosswalk template that includes sounds, lights, and graphics. Pedestrians will interpret this as an enhanced standard of care for their safety and user experience. Ensure it is applied consistently throughout the corridor to promote adherence to crossing at designated locations.

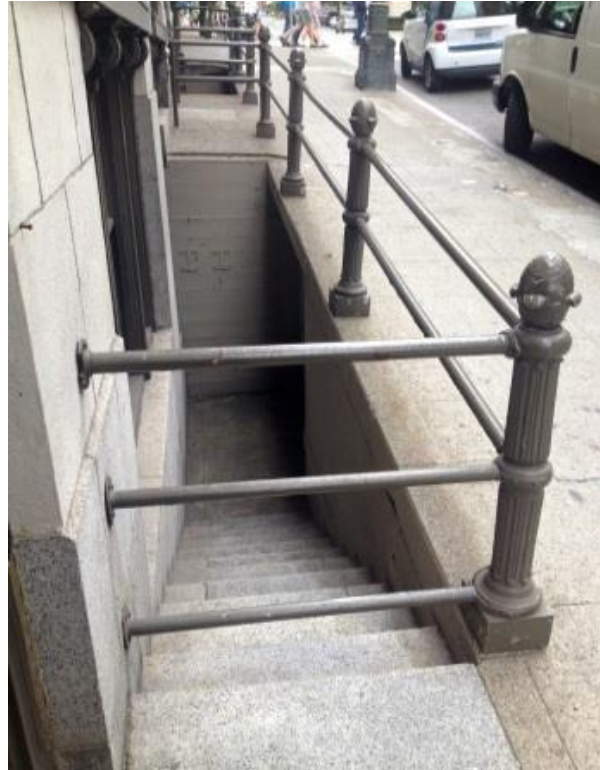
Throughout the corridor there are many alleyways that are mostly obscured from view, providing hiding places.

Work with building owners to install access barriers on all private alleyways, stairways, and alcoves using screens, railings, fencing, and posted notices.

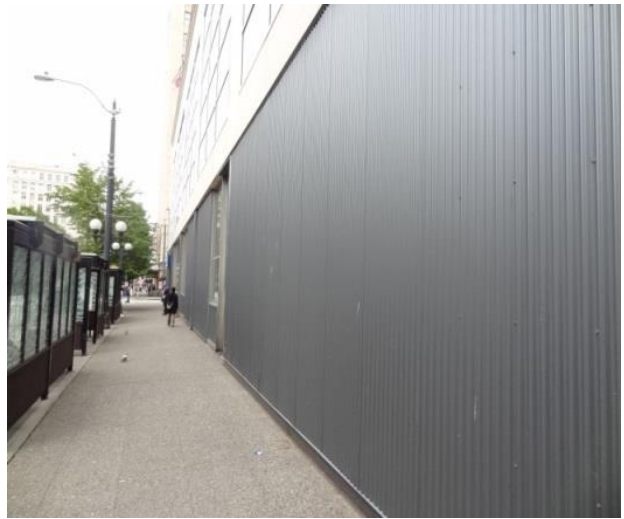
Third Avenue contains a myriad of blank walls and building facades that contribute to the perceived sense of insecurity along the corridor.

Use local artists to contribute to wall murals to increase local ownership and territoriality. Consider graffiti artists but discourage “tagging”. Examples are already present in Pioneer Square.

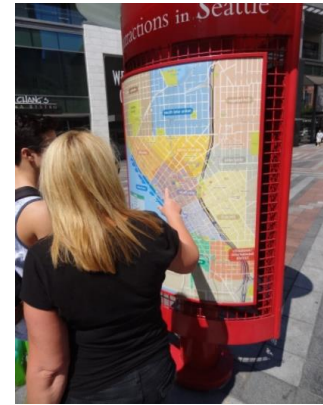
Throughout much of the corridor, there is a clear lack of wayfinding materials.

In other parts, too many different wayfinding concepts are employed.

Develop a single, consistent wayfinding template that contains user-friendly maps and diagrams.

This does not necessarily need to be a brand new template. The most cost-effective method would be to select the best wayfinding template currently in use in Downtown Seattle and standardize around it. Whichever template is selected should be updated to reflect infrastructural changes. Other wayfinding systems should be removed and replaced with the standard one.

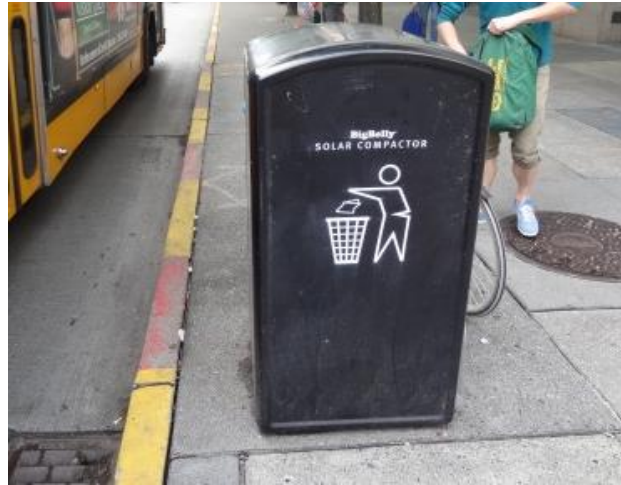
Litter receptacles and recycling bins are often next to the curbs, on corners, or near bus stops.

Depending on their placement, these amenities can conflict with the desired uses of the space available to waiting transit passengers. In the most extreme cases, poor trash can placement has led pedestrians to dart around them and into the traveled way, resulting in a number of serious accidents.

Establish a template for the consistent placement of trash cans. Move trash cans away from corners and outside of the transit zones to decrease interference with waiting transit passengers.
